## PORT OPERATIONS

### **Local Notice to Mariners 68/19**

#### **Structural Damage Pier Bravo**

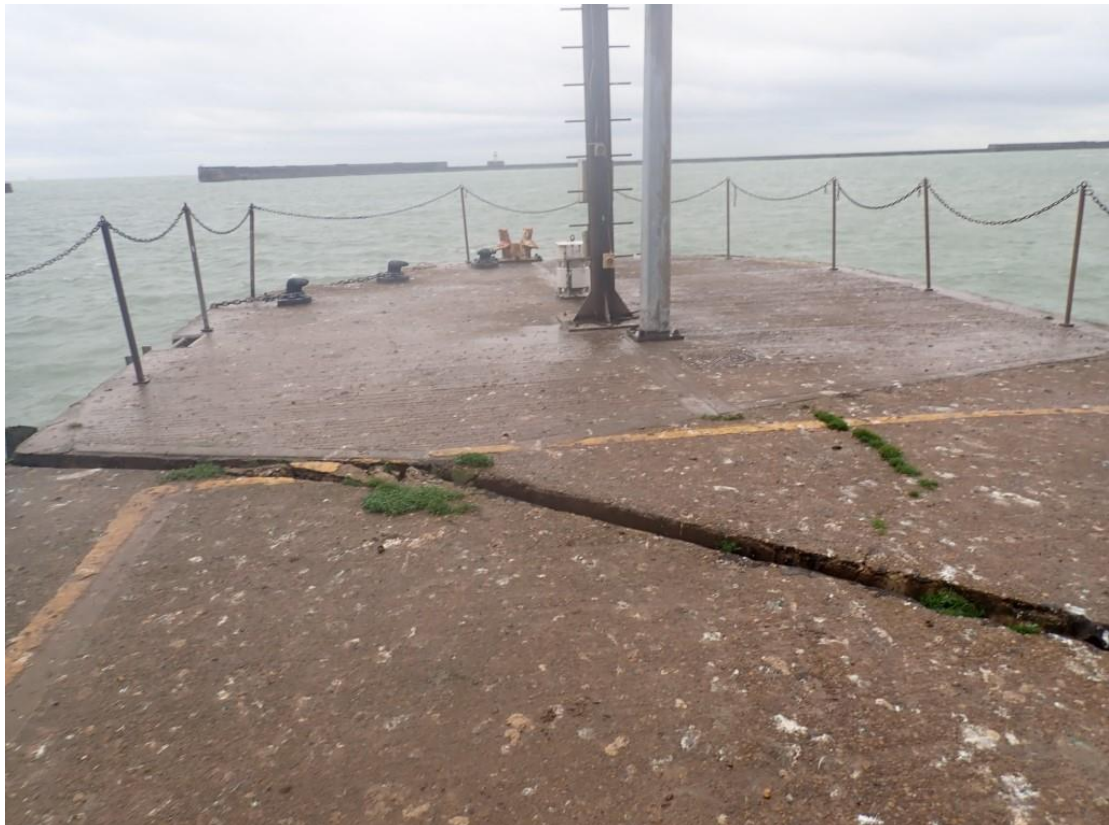
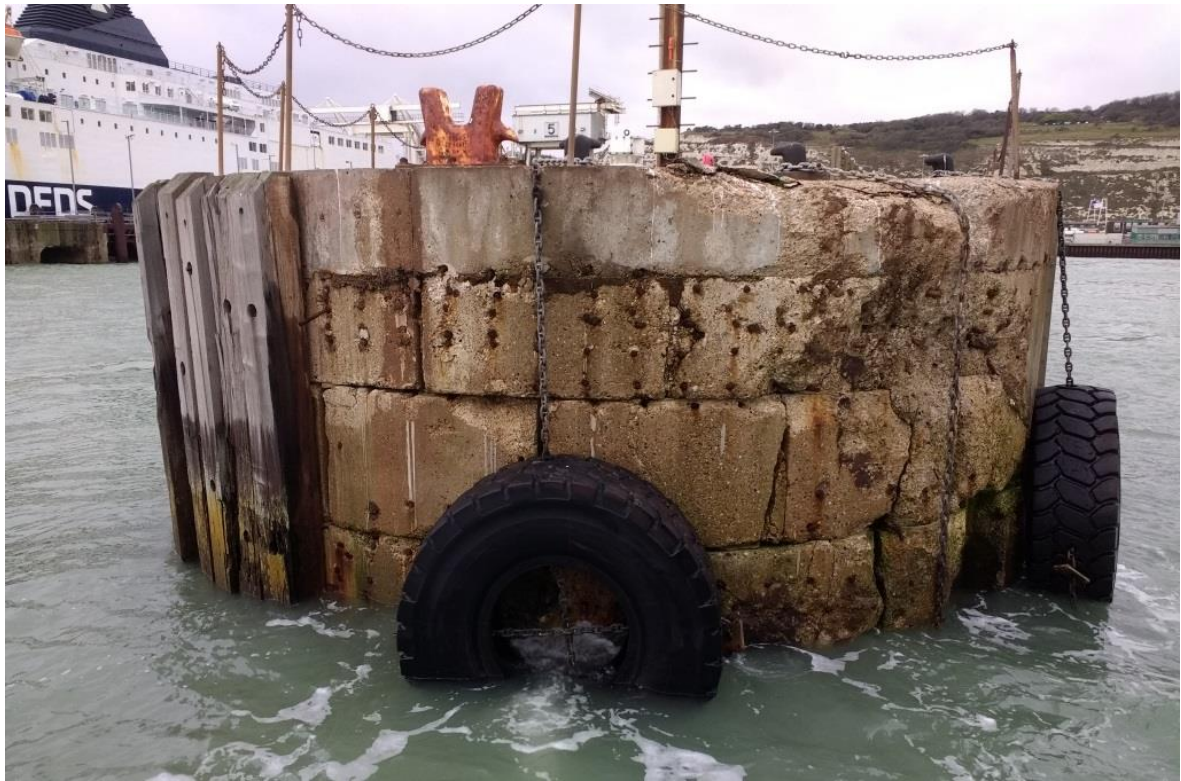
Due to recent structural damage to the end of Pier Bravo (see pictures below) and resultant concerns with the ongoing structural condition of the Pier, Mariners are advised to berth with extreme caution when manoeuvring into ED3 and in any circumstances to avoid making any contact with the seaward end of Pier B.
