PORT OPERATIONS

Local Notice to Mariners 08/19

Decommissioned mooring equipment

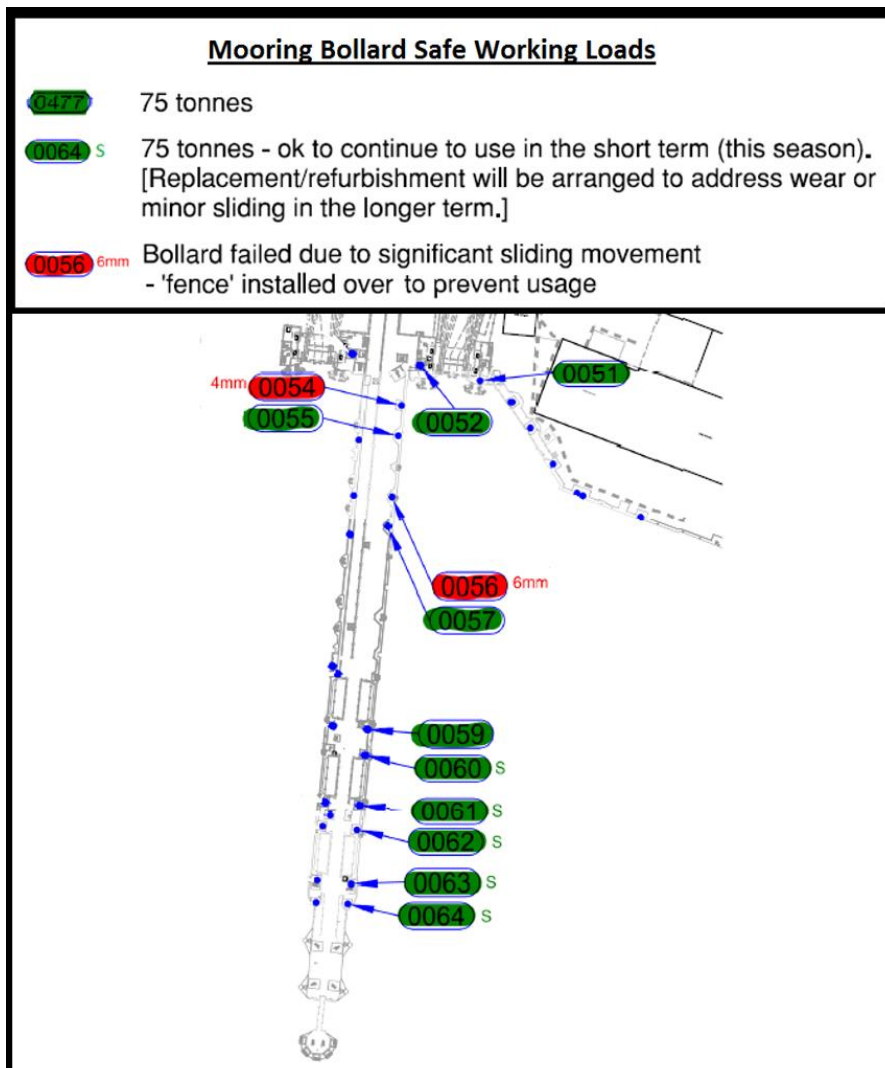
Mariners are advised that bollards 0056 and 0054 on pier A as identified below should not be used after a failed test:

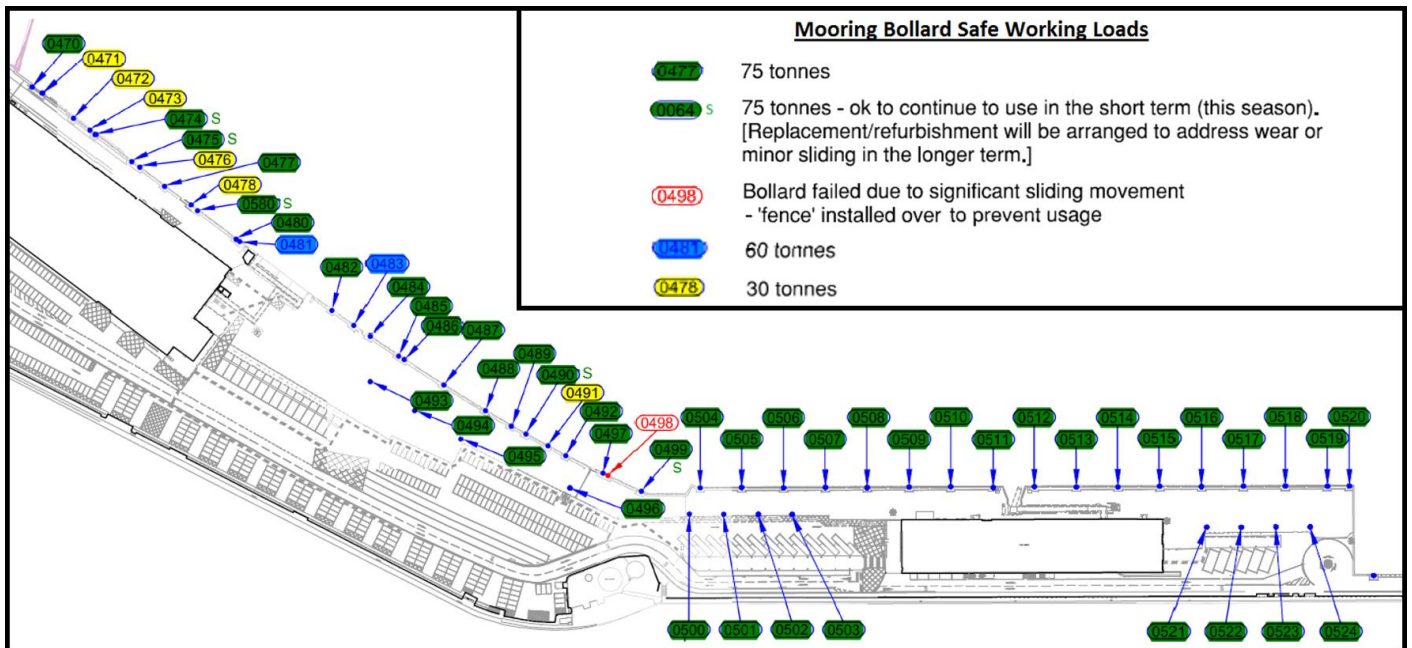
Bollard 498 on the Admiralty Pier as identified below should not be used after a failed test:

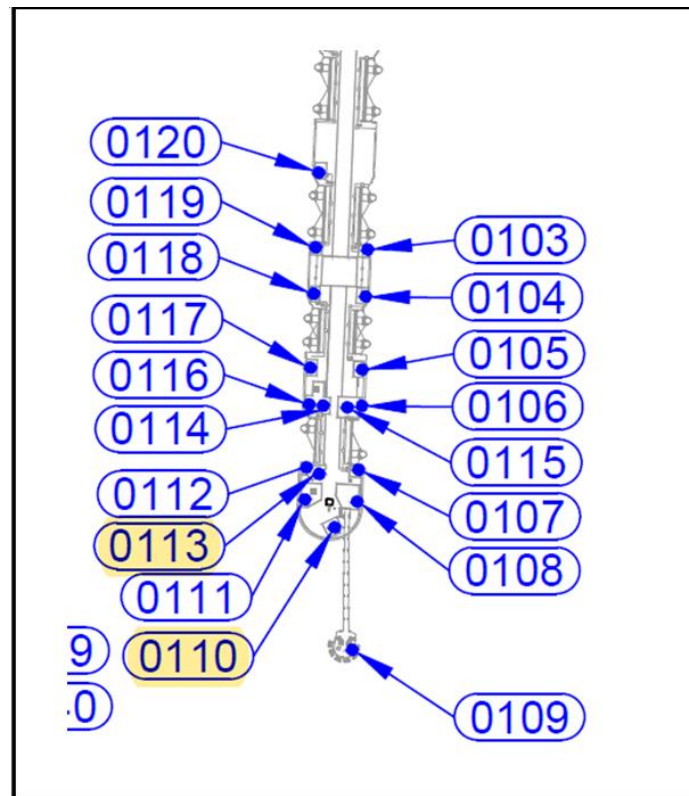
Bollards 110 and 113 on seaward end of Pier C as identified below should not be used after a failed test:
