PORT OPERATIONS

Local Notice to Mariners 35/20

Lost Anchor Eastern Docks

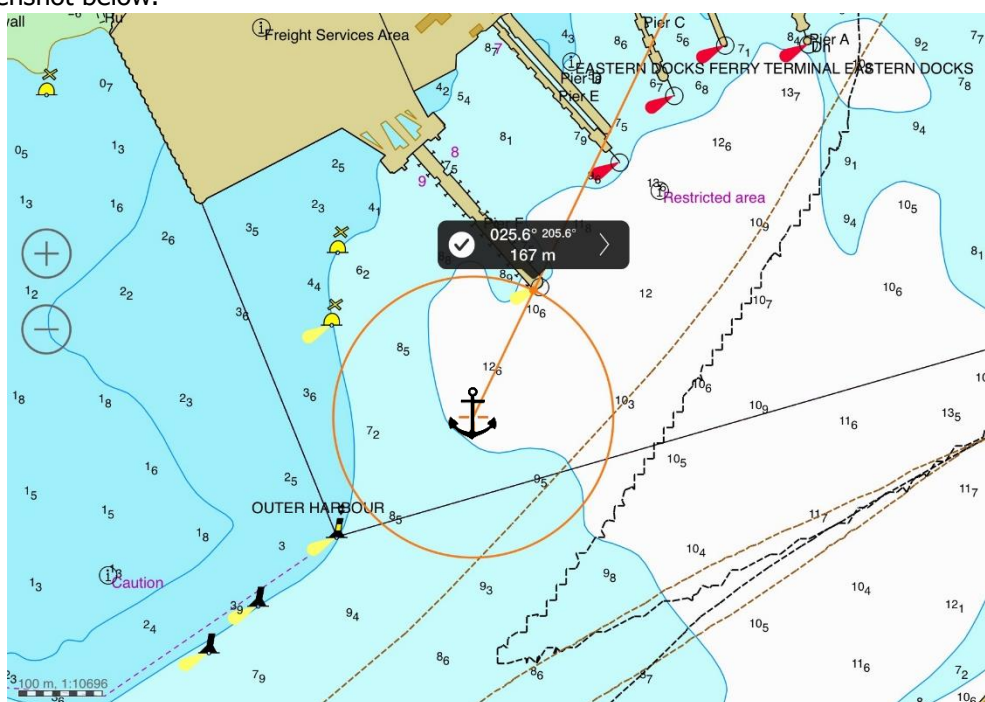
Mariners are advised that an anchor has been lost from a ferry in the Eastern Docks whilst manoeuvring for ED9. The approximate position is 51°07.257 N 001°20.02 E as per the screenshot below.

The depth of water on the latest port sounding chart is 11m below CD in that location and the anchor approximately 3m in length, potentially reducing the depth of water to 8m below CD. No anchor chain was lost.

Mariners should use extra caution when using anchors nearby to avoid fouling on this obstruction.
