PORT OPERATIONS

Local Notice to Mariners 65/20

Wick Channel Obstruction

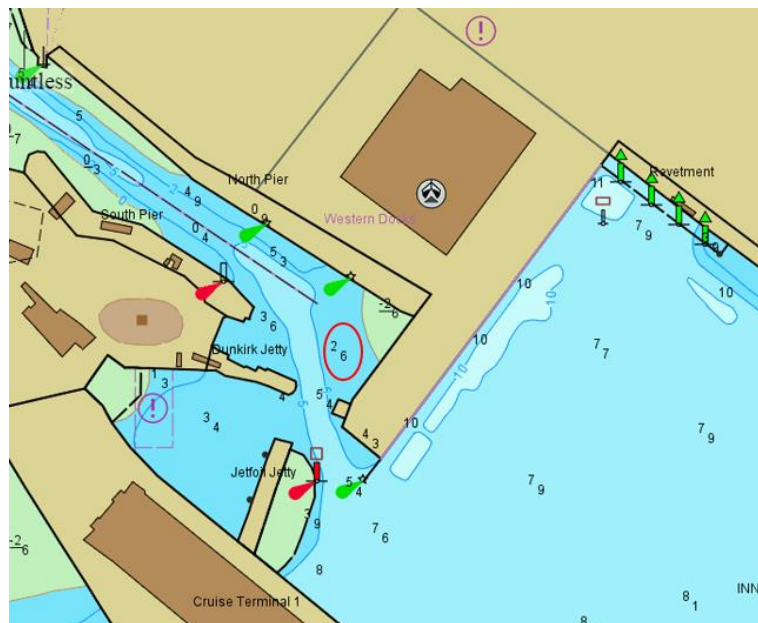
Mariners are advised that during a recent bathymetric and dive survey we have identified an object in position $51^{\circ} 06' 54.448''$ N and $001^{\circ} 18' 56.9257''$ E. The object appears to be a 3mx3mx1.5m concrete block, which sits just east of the main channel and is highlighted on the chart below by a red circle.

Mariners passing through the Wick Channel should exercise extreme caution whilst manoeuvring through the Wick Channel and take into account the navigational hazard, which sits at 2.6m above chart datum.
